INTERNATIONAL INTERMEDIATE BULK CONTAINER FIRE TEST PROJECT

Required Delivered Density Tests

TECHNICAL REPORT

Fire Testing of Intermediate Bulk Containers

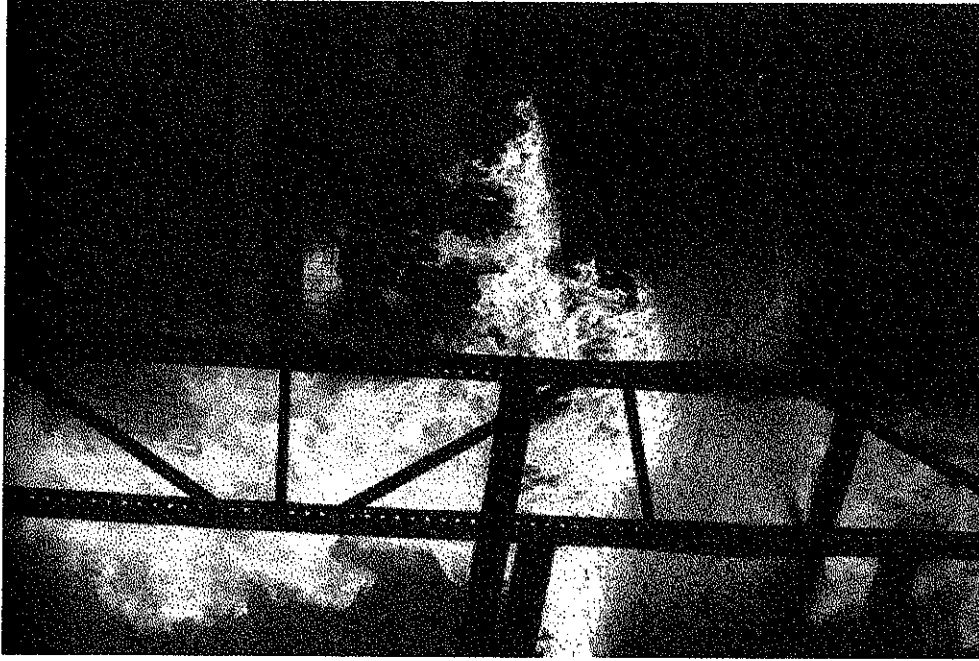
Figure 5 - Fuel overflowing onto the floor

Typically, the pool fire would continue to burn when the suppression system was activated (see Figure 4). The liquid level in the pan would rise until it was even with the pan lip, at which time the burning of the pool intensified because of the increased surface area. Shortly thereafter, fuel would overflow onto the floor (Figure 5). This created a short duration, higher intensity fire as the fuel burned out. Time to overflow the pan was on the order of four to six minutes for the 0.6 gpm/ft² (24 mm/min) tests and on the order of seven and one-half minutes for the 0.3 gpm/ft² (12 mm/min) tests. The higher intensity floor fire is typically characterized by spikes in the heat release data shown in Appendix B. The fire would then burn out soon (typically about 1 minute) after the overflow of fuel on the floor.

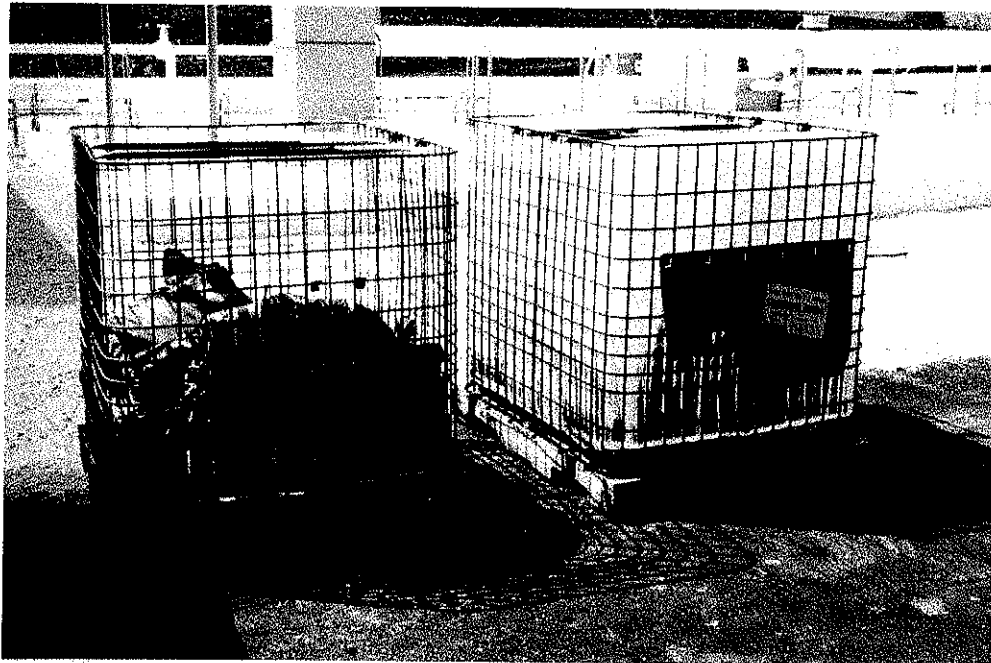
Figure 8 - Post-test damage, Test #2

minutes, the pool fire had spilled out onto the floor, and at 7 minutes, the fire was extinguished with hose lines. The lower plastic bottle melted; the upper bottle was not breached (Figure 8).

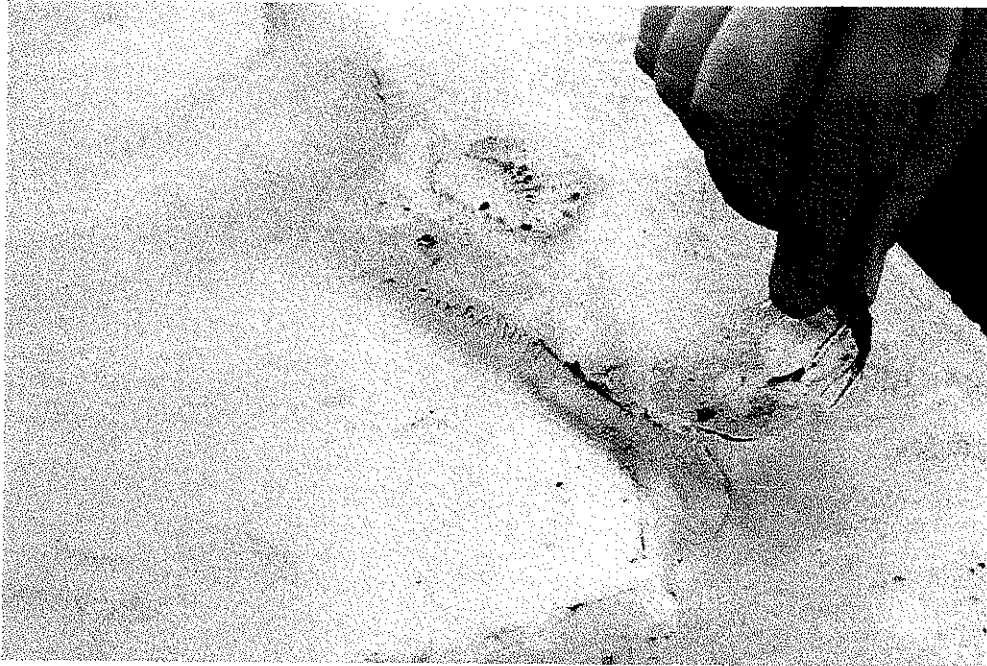
Figure 10 - Melting of Unit #9 after Test #3

There were no breaches or leaks. Damage to the lower unit was limited to surface charring of the wood pallet. The polystyrene cushions inside each unit remained mostly intact. Both plastic bottles, when removed from the steel shell, had smooth surfaces that indicated that some melting had occurred (Figure 10). The pallet of the upper unit was essentially undamaged.

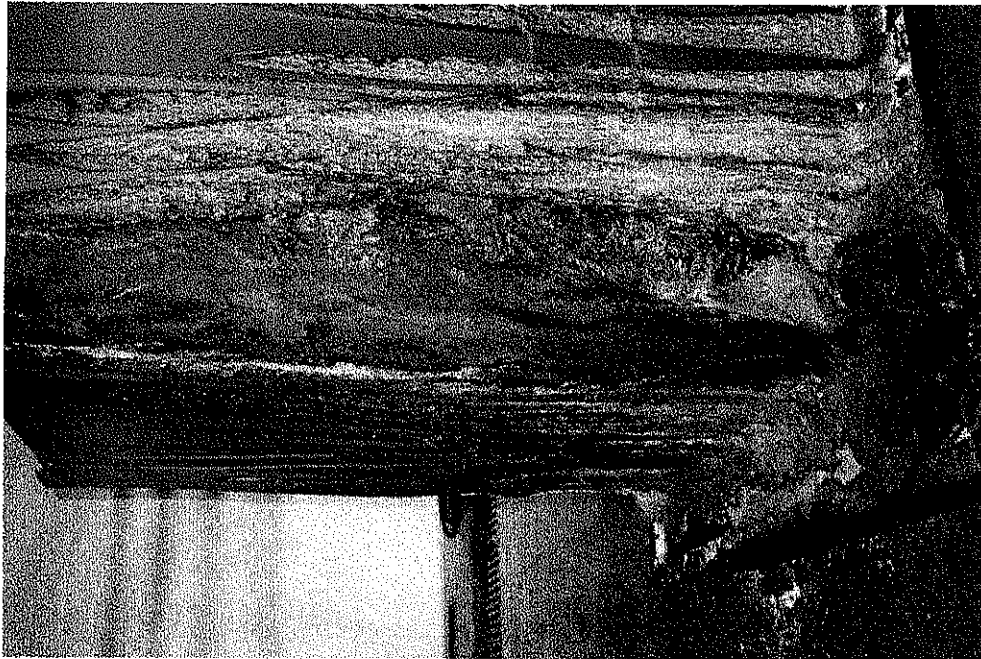
Figure 15 - Solid plastic over pool area, Test #9

remaining burning was a plastic fire. As in the previous failure mechanism tests, a solid mass of plastic formed over the pan area (Figure 15). The suppression system was able to control this fire. Small fires persisted on the lower unit for a period of about 25 minutes until three small fires were manually extinguished. There was no breach of the lower liquid bottle or in the upper unit.
